## Axle Bill Of Materials

750 Series Drum Brake

300mm x 135mm

*80279 REV C*

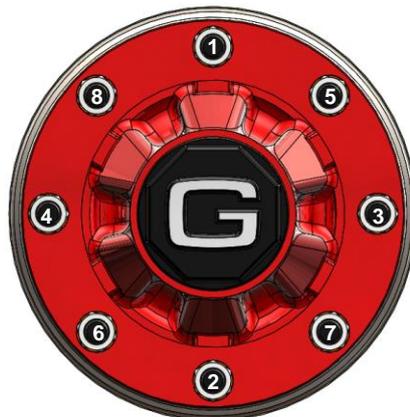
To achieve correct tension in each of the wheel locating bolts, and thus optimum wheel security, Tighten wheel nuts in the order shown below.

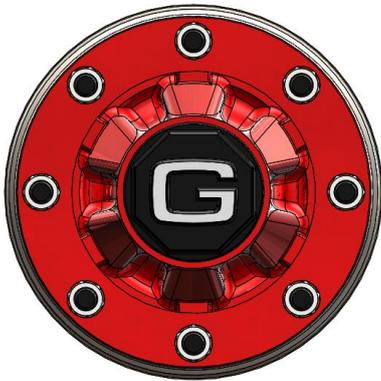
Hub cap is removed

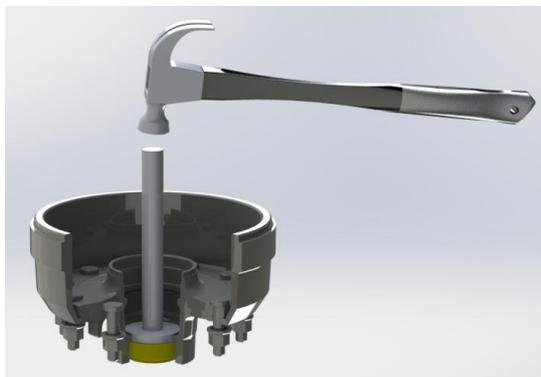
Outer bearing cone being removed.

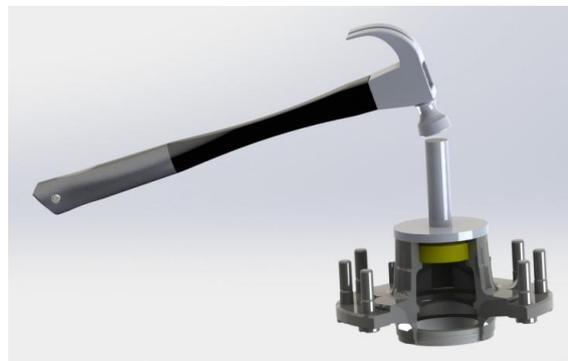
Outer bearing cone being fitted

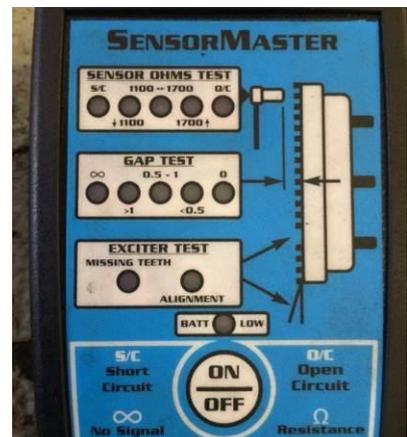
If the ABS pole wheel is being replaced or fitted, 80 tooth (Part no. 61789), it is important that it is fully seated on the hub and it is perfectly parallel to the hub face otherwise it will create an ABS fault reading. If replacing or changing the ABS sensor ensure it is properly coated with the supplied anti fretting paste.
