Axle Service Manual

960 Series Drum Brake 10 spline

980 Series Drum Brake 10 spline

Internal /External Drum, 420mm x 180mm

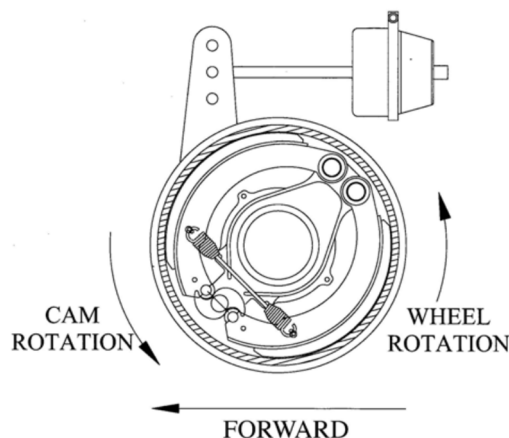
To assure safe operation and maximum durability on parts such as brake linings and tyres, it is necessary to position and install the axle properly. It is essential that the axle assembly be installed so that the cams rotate in the same direction as the wheels in FORWARD travel.

Installation in which the camshaft rotation is opposite to that of the wheel rotation could cause noisy brakes, chatter and wheel 'hop'. With this in mind, the axle should be ordered with placement of air chamber and slack adjuster assemblies that will ensure the correct directional rotation of the cams when the axle is installed.

See below.

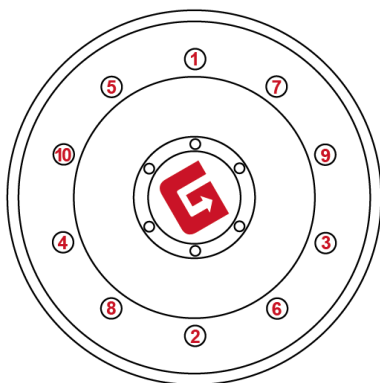
To achieve correct tension in each of the wheel locating bolts, and thus optimum wheel security, Tighten wheel nuts in the order shown below.

570-630Nm

Above is the torque for the internal nut used on some axle models

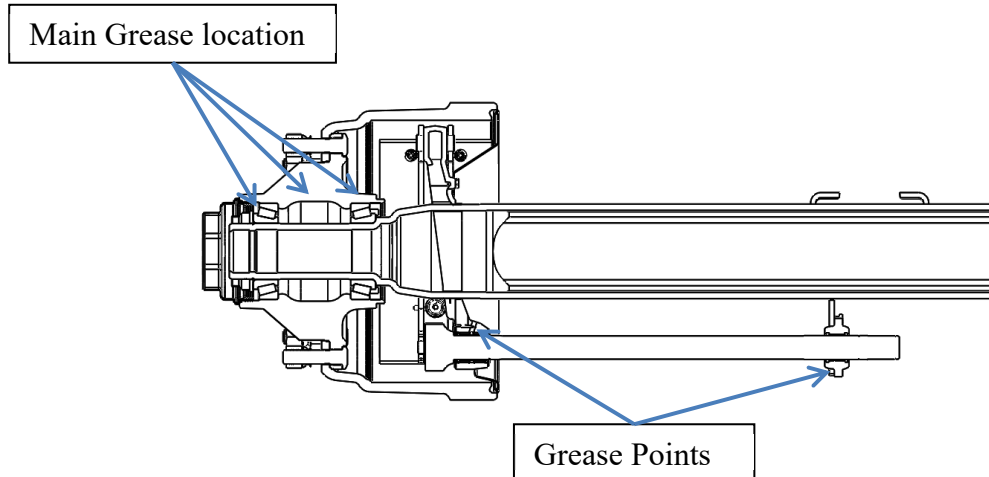
Apply grease to these areas. It is important not to overfill the hub with grease!

Hub: 400 grams

Hub Cap: Small amount

Care: Greasing at high pressure may cause damage to the seals

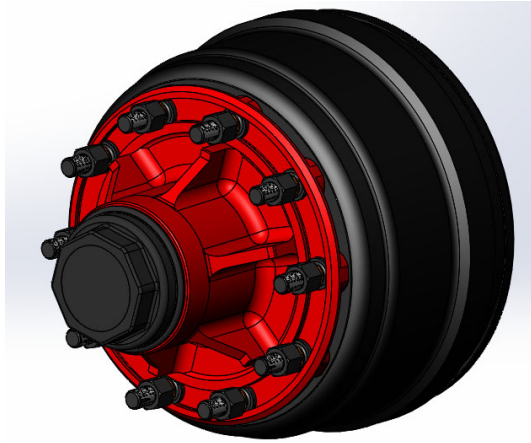
For internal drum axles the hub and drum has to be removed in one go. Caution must be used when removing this assembly due to its weight and potential to suddenly slide off the axle spindle.

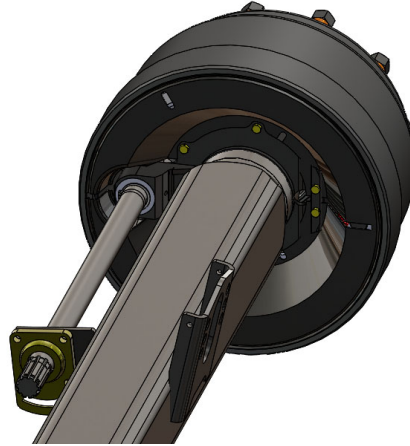
The dust cover is easily removed by unscrewing the 6 x M8 bolts.

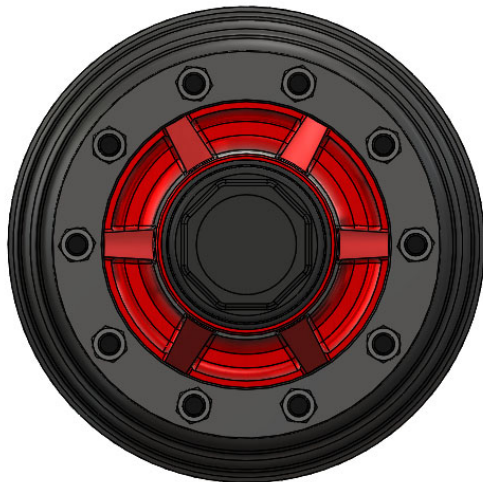
Undo the Hub cap

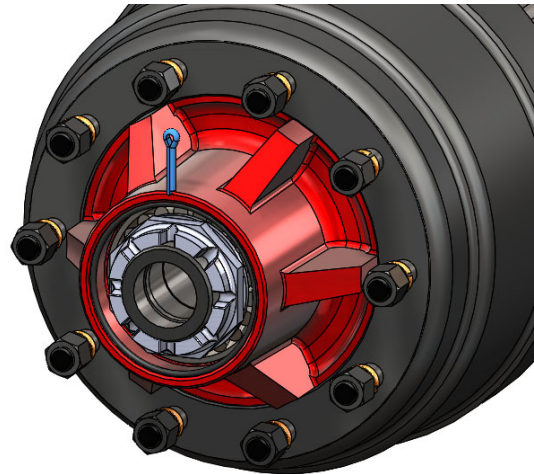
Straighten cotter pin tab's & remove it

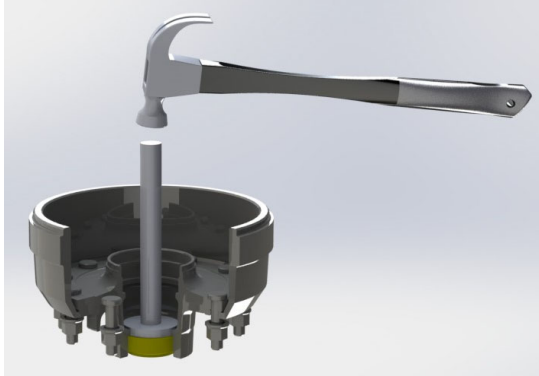
Outer bearing cone being removed.

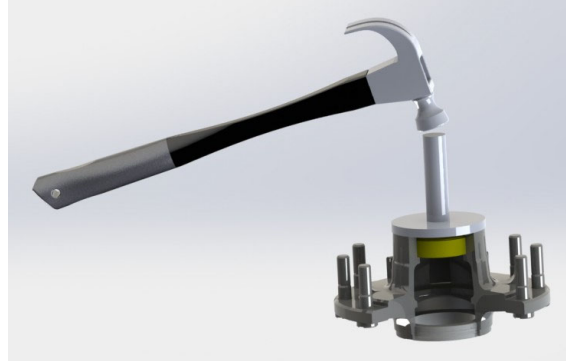
Outer bearing cone being fitted

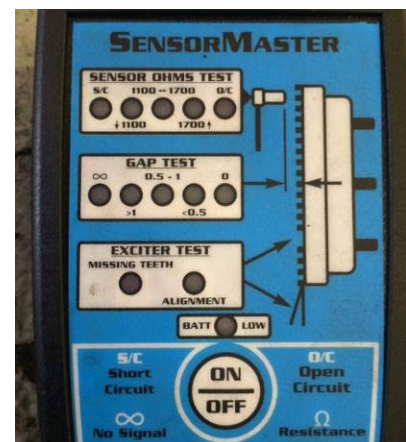
If the ABS pole wheel is being replaced or fitted, it is important that it is fully seated on the hub and it is perfectly parallel to the hub face otherwise it will create an ABS fault reading. If replacing or changing the ABS sensor ensure it is properly coated with the supplied anti fretting paste.
